AIR SERVICE INFORMATION CIRCULAR

REPORT OF STATIC TEST OF XB-1-A FUSELAGE

Prepared by Engineering Division, Air Service
McCook Field, Dayton, Ohio
January 4, 1922

REPORT OF STATIC TEST OF XB-1-A FUSELAGE.

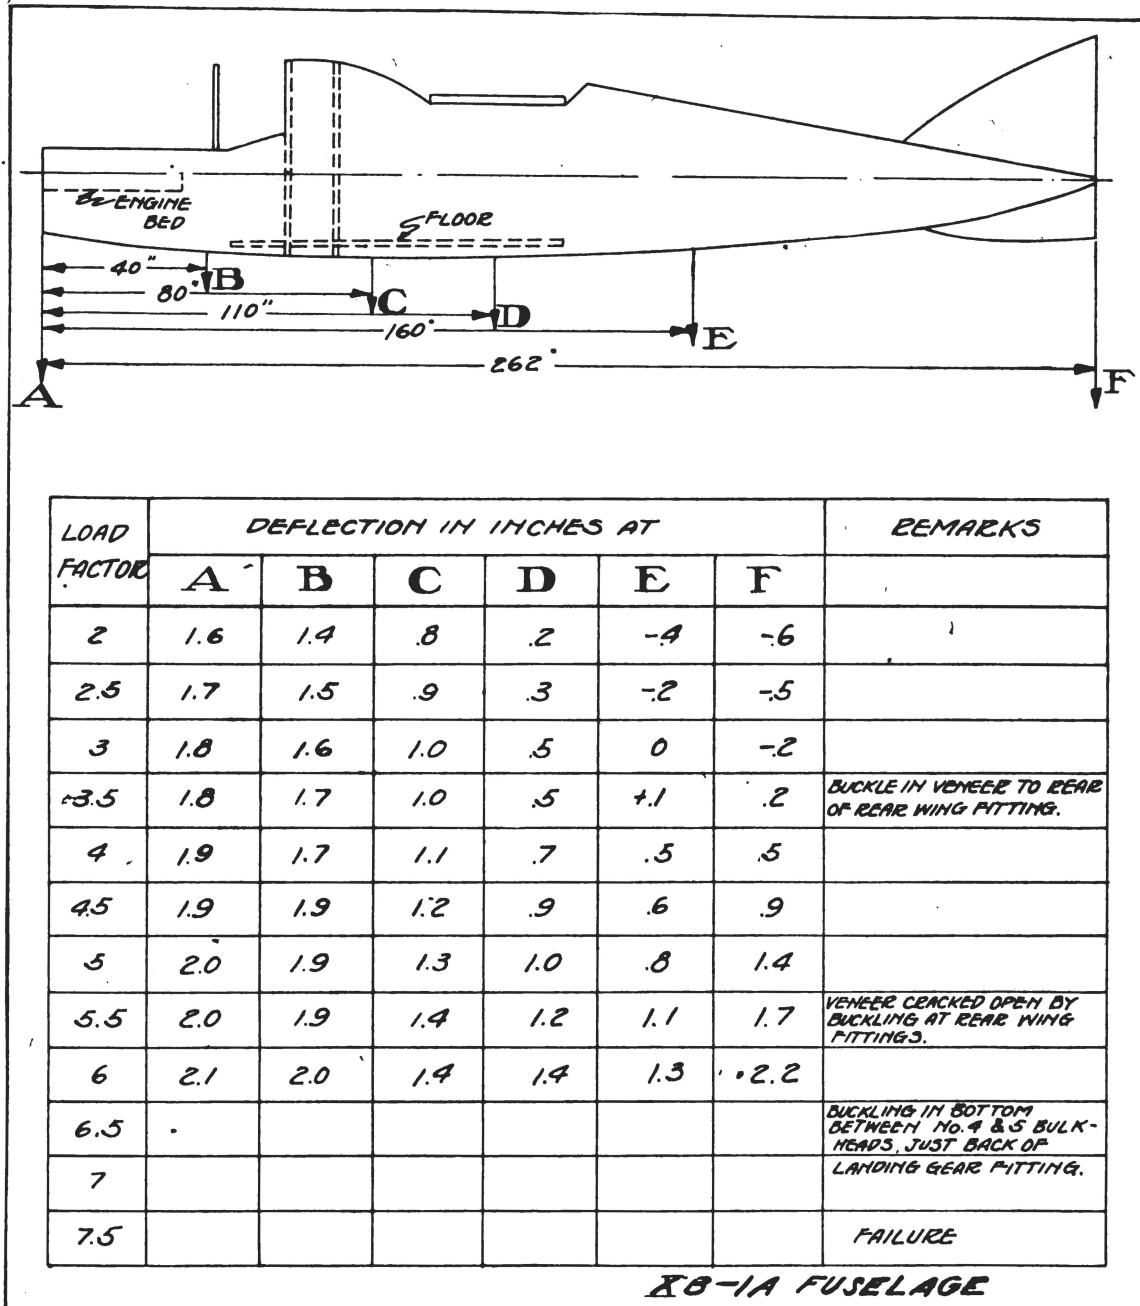
FIG. 4.

The deflections in inches and the tabulated results may be seen in figure 4.

At a load factor of 3.5 the veneer skin buckled at a point just to the rear of the rear wing fittings.

When a factor of 5.5 was reached the veneer cracked on both sides at the rear wing fittings.

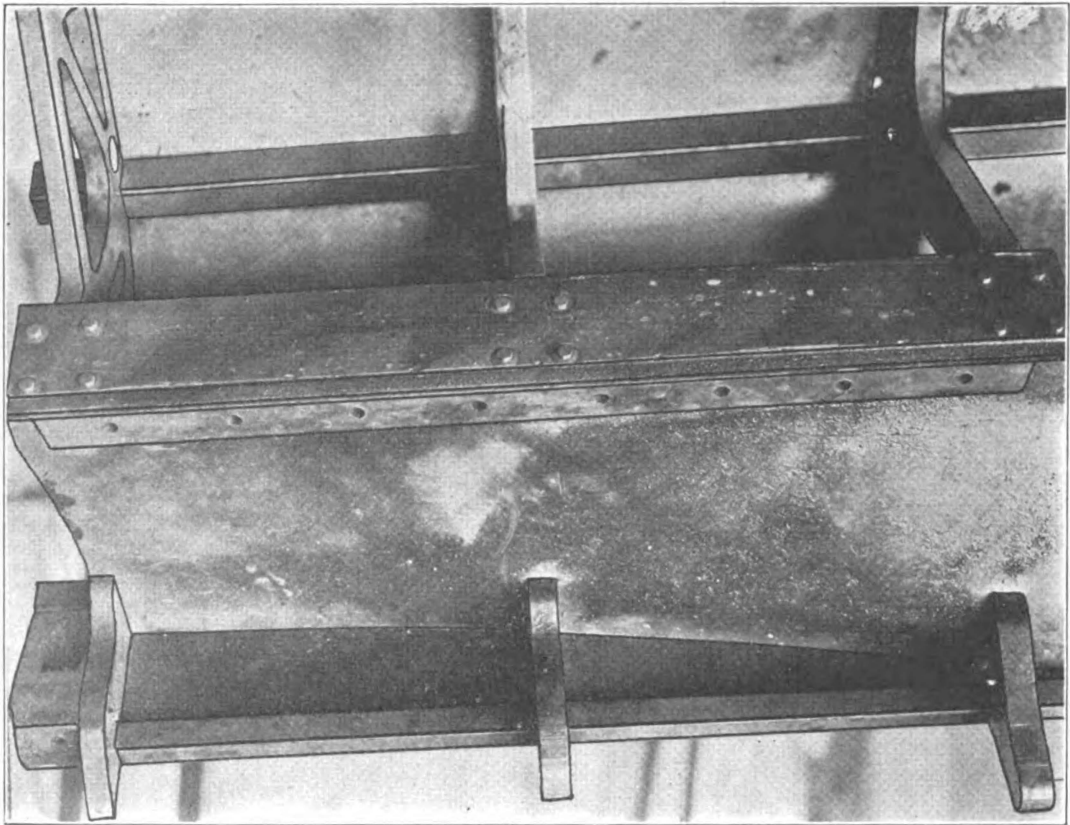
FIG. 5.

The paint on the engine bearers was blistered with heat as seen in figure 5.

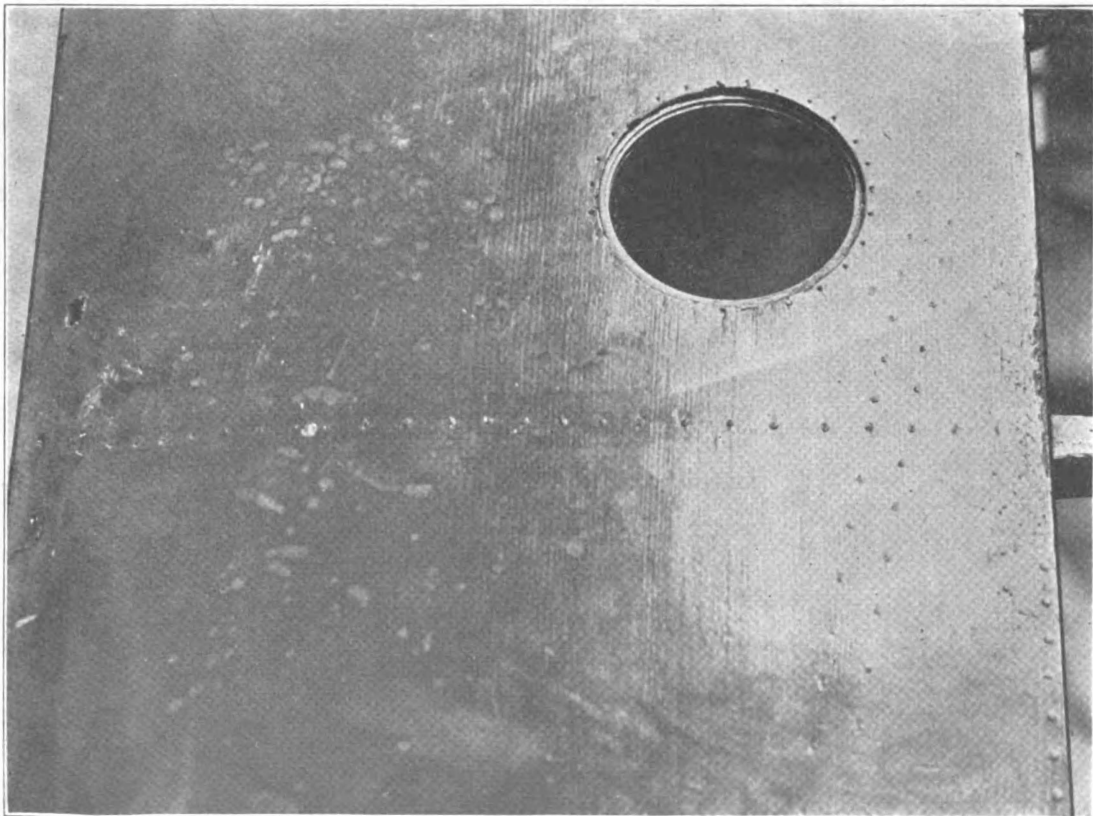
FIG. 6.

No. 3 bulkhead was pulled loose from the longerons on the lower right side.

No. 3 bulkhead was pulled away from the plywood covering on both sides and bottom, due to shocks received in landing.

The nails were pulled on No. 3 bulkhead on the right side, as shown in figure 6.

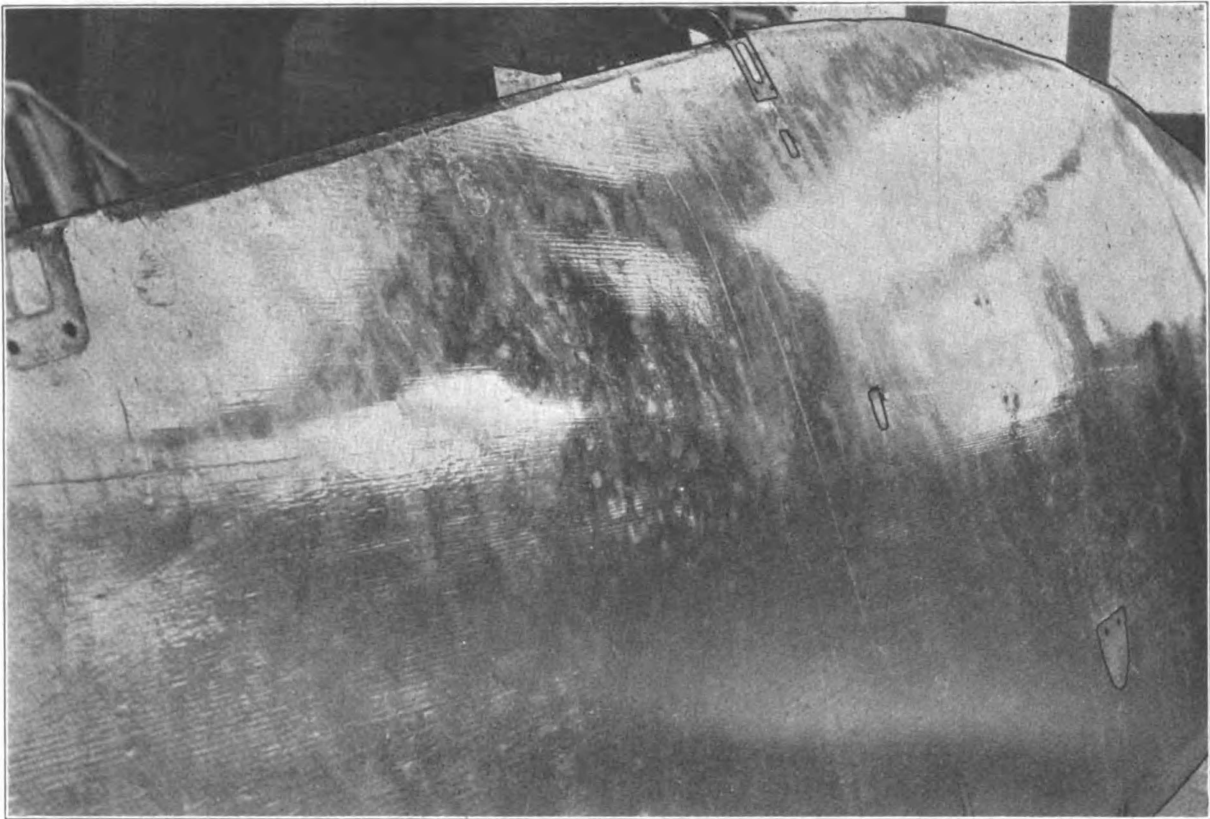
FIG. 7.

The plywood skin was buckled on the left side, as shown in figure 7.

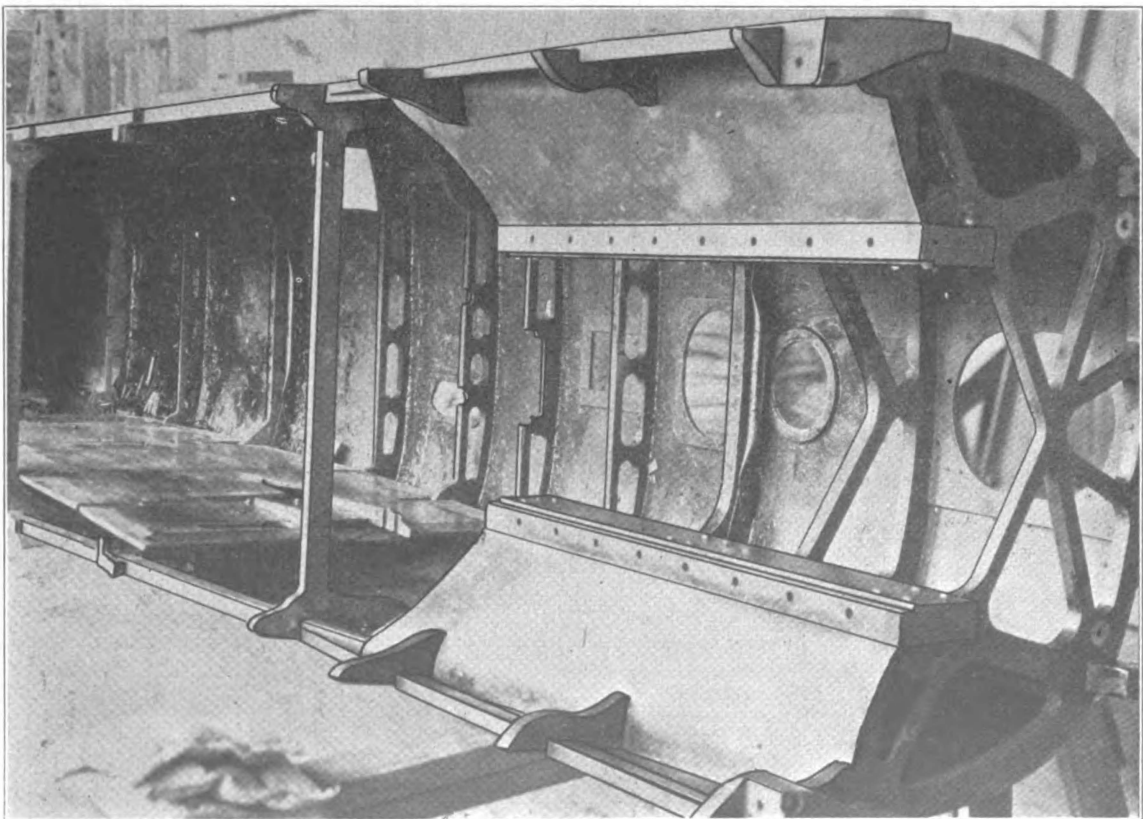
FIG. 8.

The whole bottom of the fuselage was covered with oil. Figure 8 shows the condition of the bottom of the fuselage.

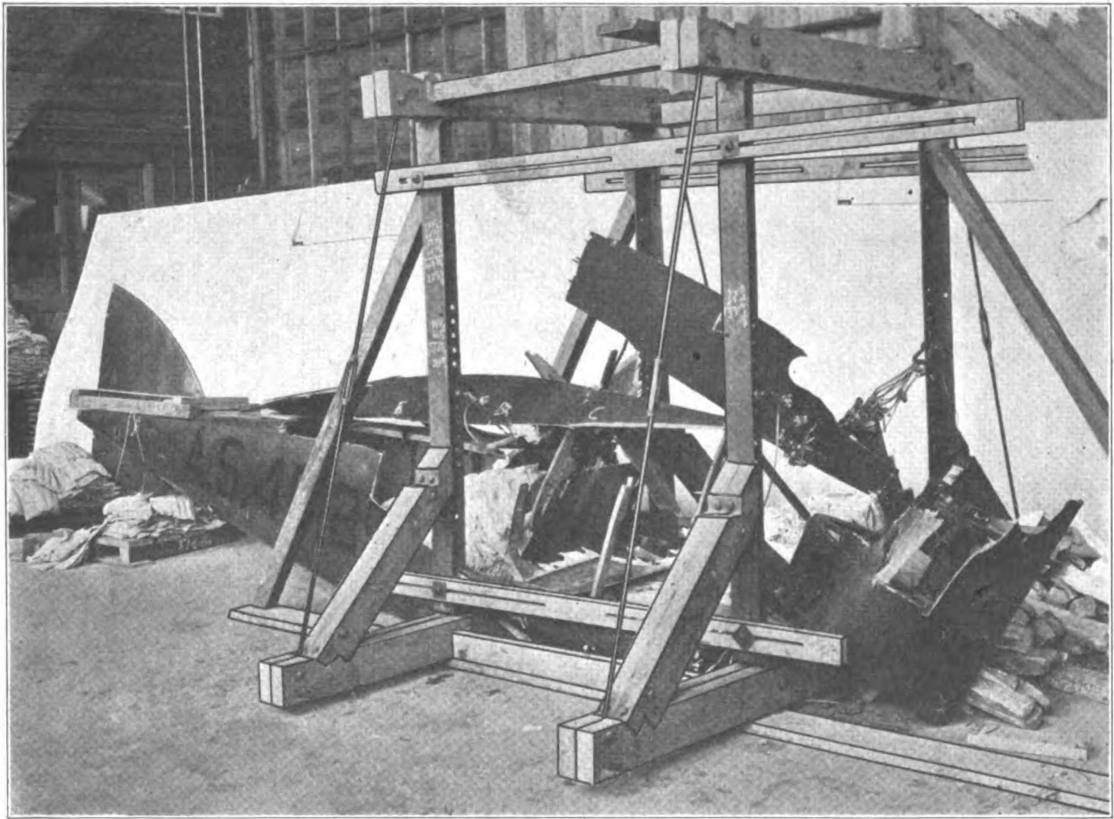
FIG. 9.

At a load factor of 6.5 and 7 the veneer skin buckled on the bottom between bulkheads 4 and 5 back of last landing gear fittings.

Complete failure occurred at a load factor of 7.5.

Figure 9 is a photo of the failure.
